Partition to Column Detail

Stub Column Section at Main Frame Endwall

Sprinkler Pipe Hanger Detail

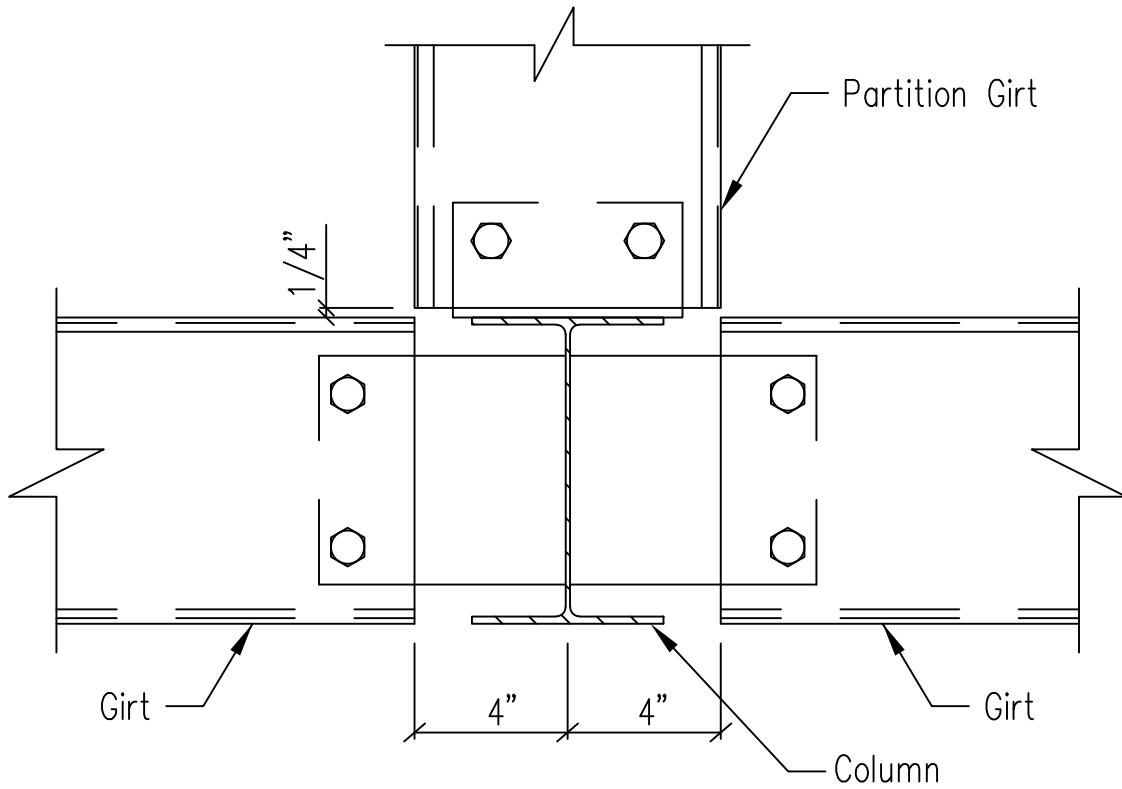
SD120

Detail with Hot Rolled Column

Note: All connection bolts are 1/2" x 1 1/4" machine bolts unless noted.

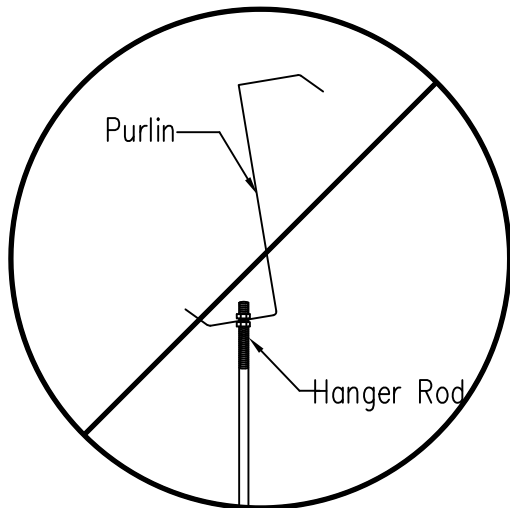
WRONG

Do Not Install Hanger Rod in the Flange of Purlin

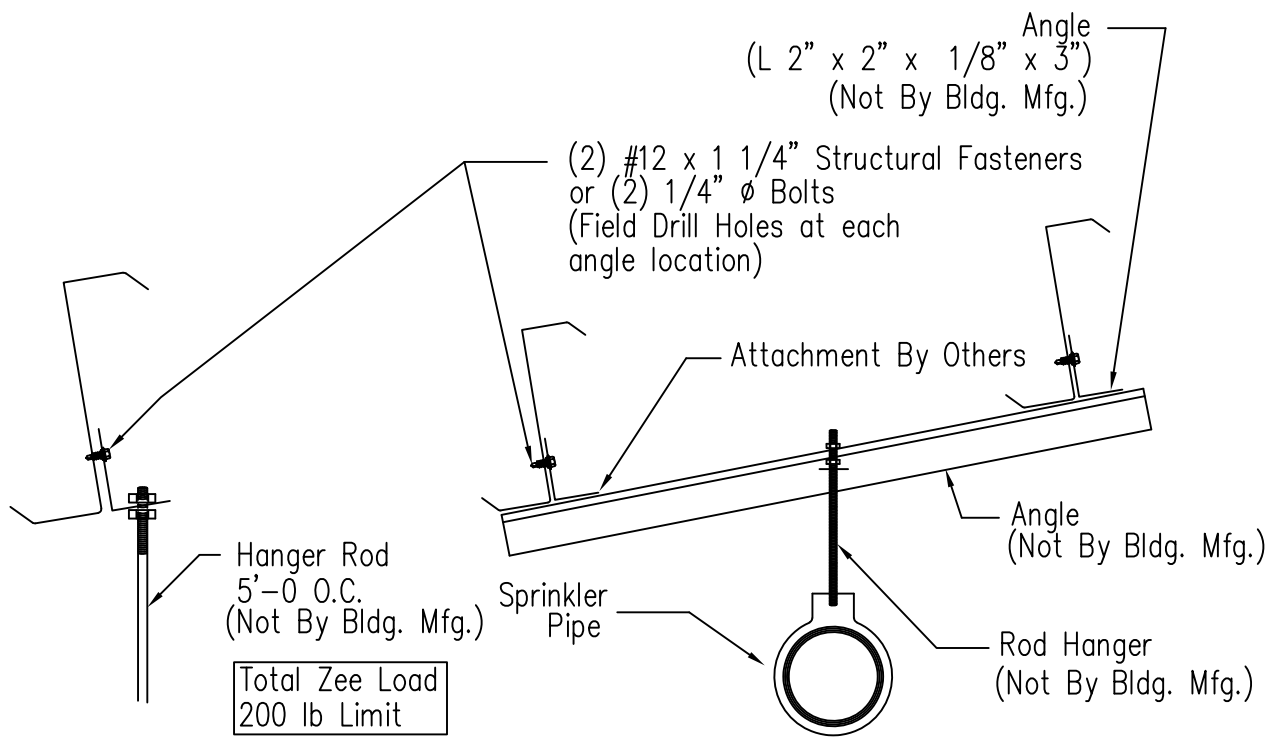
SD160

Detail at Purlin

Detail Between Purlins

All Bolts are 1/2" x 1 1/4"

A307 M. Bolt

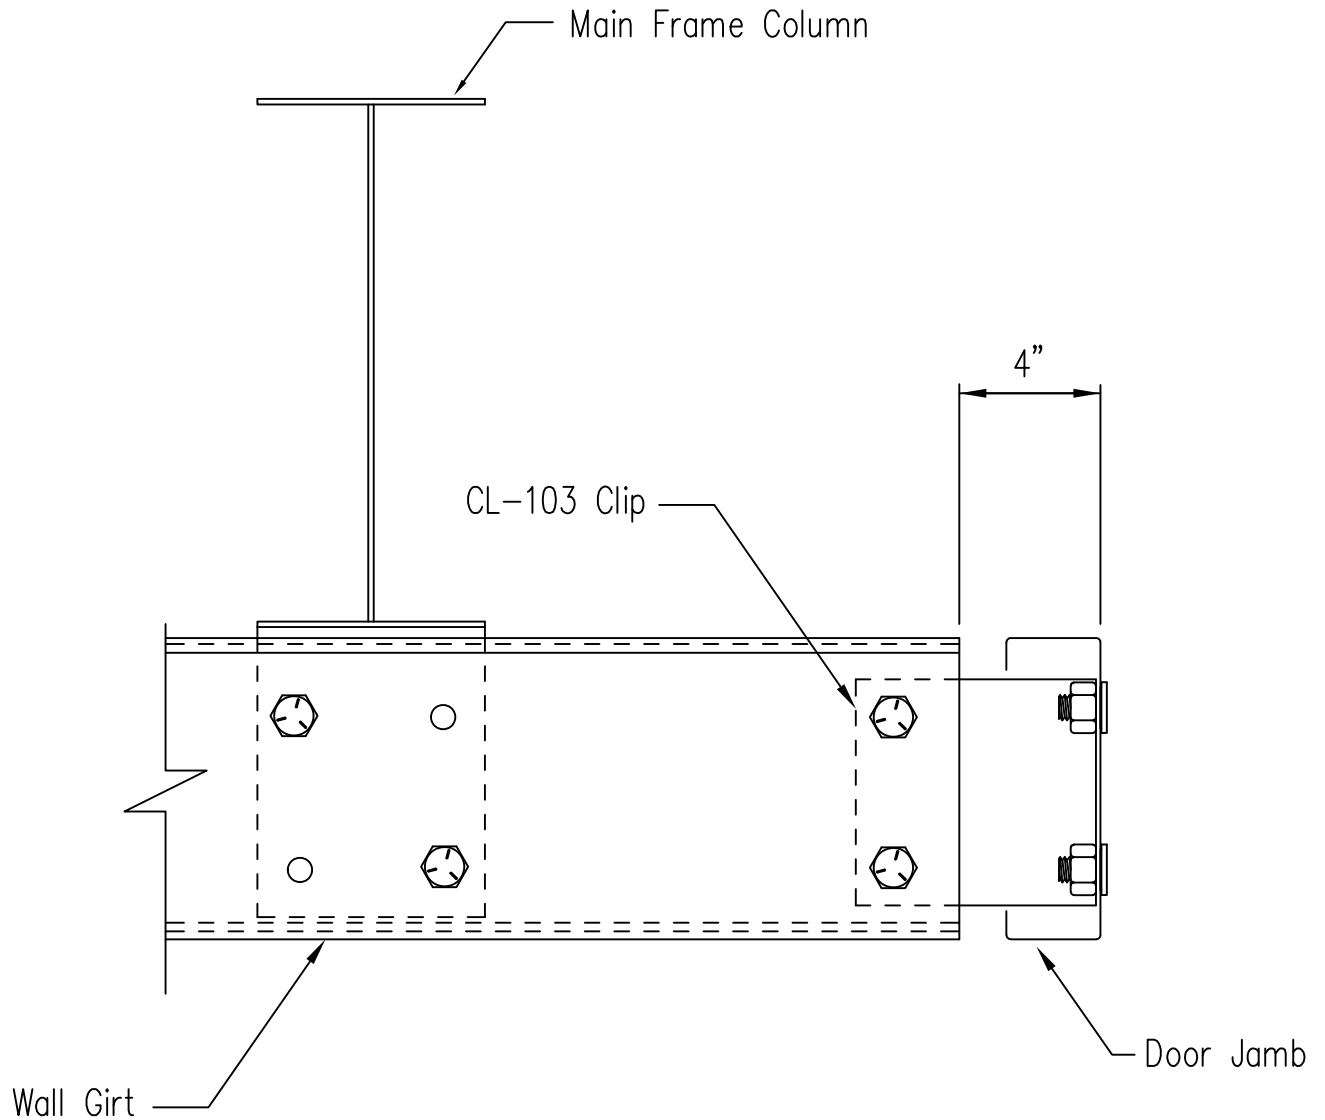
SD166

ERECTOR NOTE: IF CLIP BOXES ON BUILDING ELEVATION VIEW(S) ARE BELOW THE INTENDED GIRT LINE, THE CLIP(S) IN REFERENCE ARE TOED DOWN. IF ABOVE THE GIRT LINE, THEN TOED UP.

No Lap Near Framed Opening
